**8th IWA-ASPIRE
Conference and Exhibition**
31 OCTOBER - 2 NOVEMBER 2019 • HONG KONG

Water And Sanitation Status Under Emergency Situation After Palu-Sigi-Donggala Disaster

WATER AND SANITATION STATUS UNDER EMERGENCY SITUATION AFTER PALU-SIGI-DONGGALA EARTHQUAKE

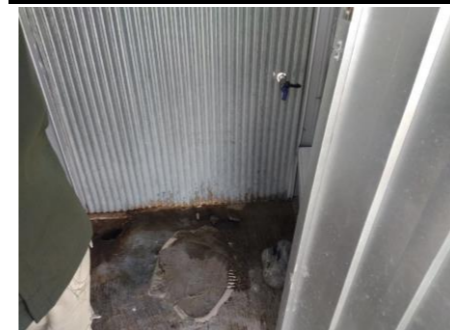
In terms of sanitation aspects, from 5 shelters observed, 3 of them were in concerning condition. Number of emergency shelter toilets were built incorrectly and led to closure; Some toilets were built on unstable soil; Some has puddled blackwater and greywater due to overflow or disconnected pipes flow untreated to the drainage system. These conditions increased the risk of exposure to faecal matter of the dwellers and thus making the risk of water-borne diseases outbreak increased.

Figure 3 – Toilet covered with concrete to stop usage due to incorrect construction in Petobo Shelter

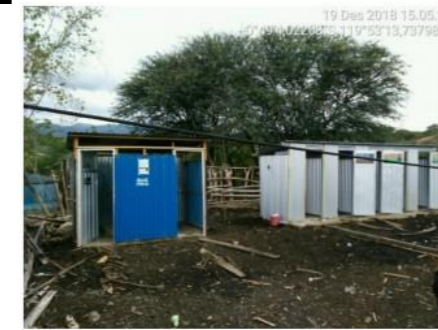
Figure 4 – Toilets built on unstable soil in Layana Shelter

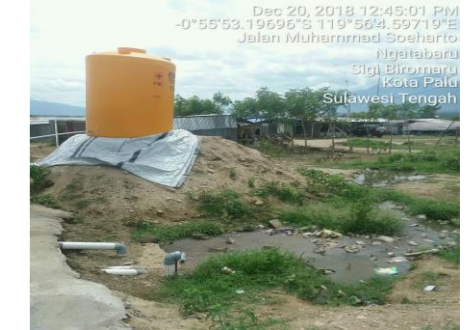
Figure 5 – Puddled water due to septic tank overflow in Petobo Shelter

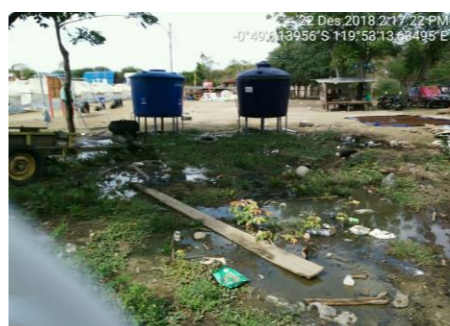
Figure 6 – Puddled water due to bad placement of water tank in Layana Shelter

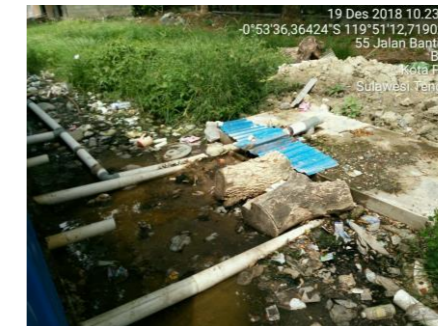
Figure 7 – Puddled water due to disconnected blackwater pipe in Masjid Agung Shelter

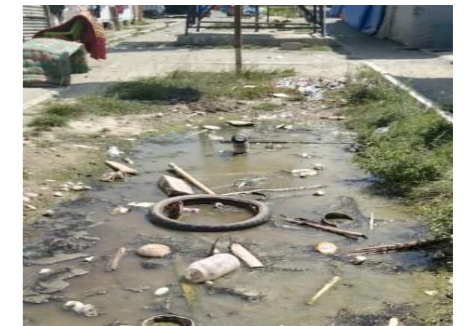
Figure 8 – Puddled water due to septic tank overflow in Bangsa Shelter

In the most recent field observation focusing on available toilet quality along with its on-site treatment in recovery shelters, it was found that access to water and toilet in term of safety and comfort were considerably acceptable as shown in **Figure 9**. However, problems occurred in the treatment part of the chain, in which due to the absence of leaching pit after treatment and soil inability to infiltrate effluent, puddles are formed in some area and causing nuisance (**Figure 8**).

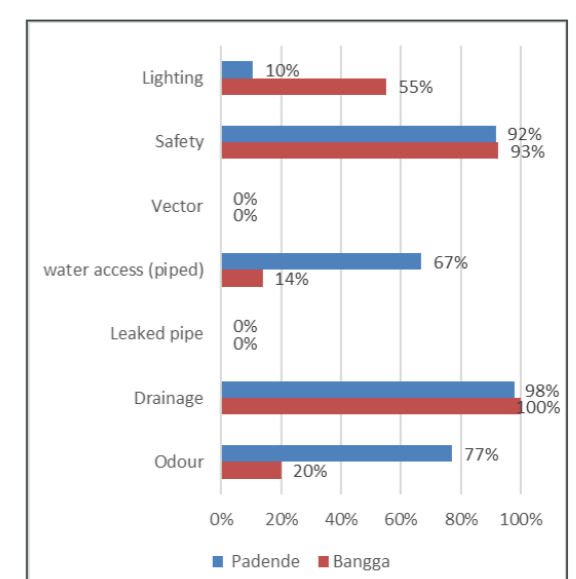
Figure 9 – Toilet condition in Bangsa and Padende Temporary Shelter
